BOEING AEROSPACE CO HOUSTON TX SPACE DIV
SNEAK CIRCUIT ANALYSIS OF F-4C FLIGHT CONTROL SYSTEM, (U)
SEP 74 P F STOKES

D2-118545-1

Sneak Circuit Analysis of F-4C Flight Control System

SEPTEMBER, 1974
HOUSTON, TEXAS

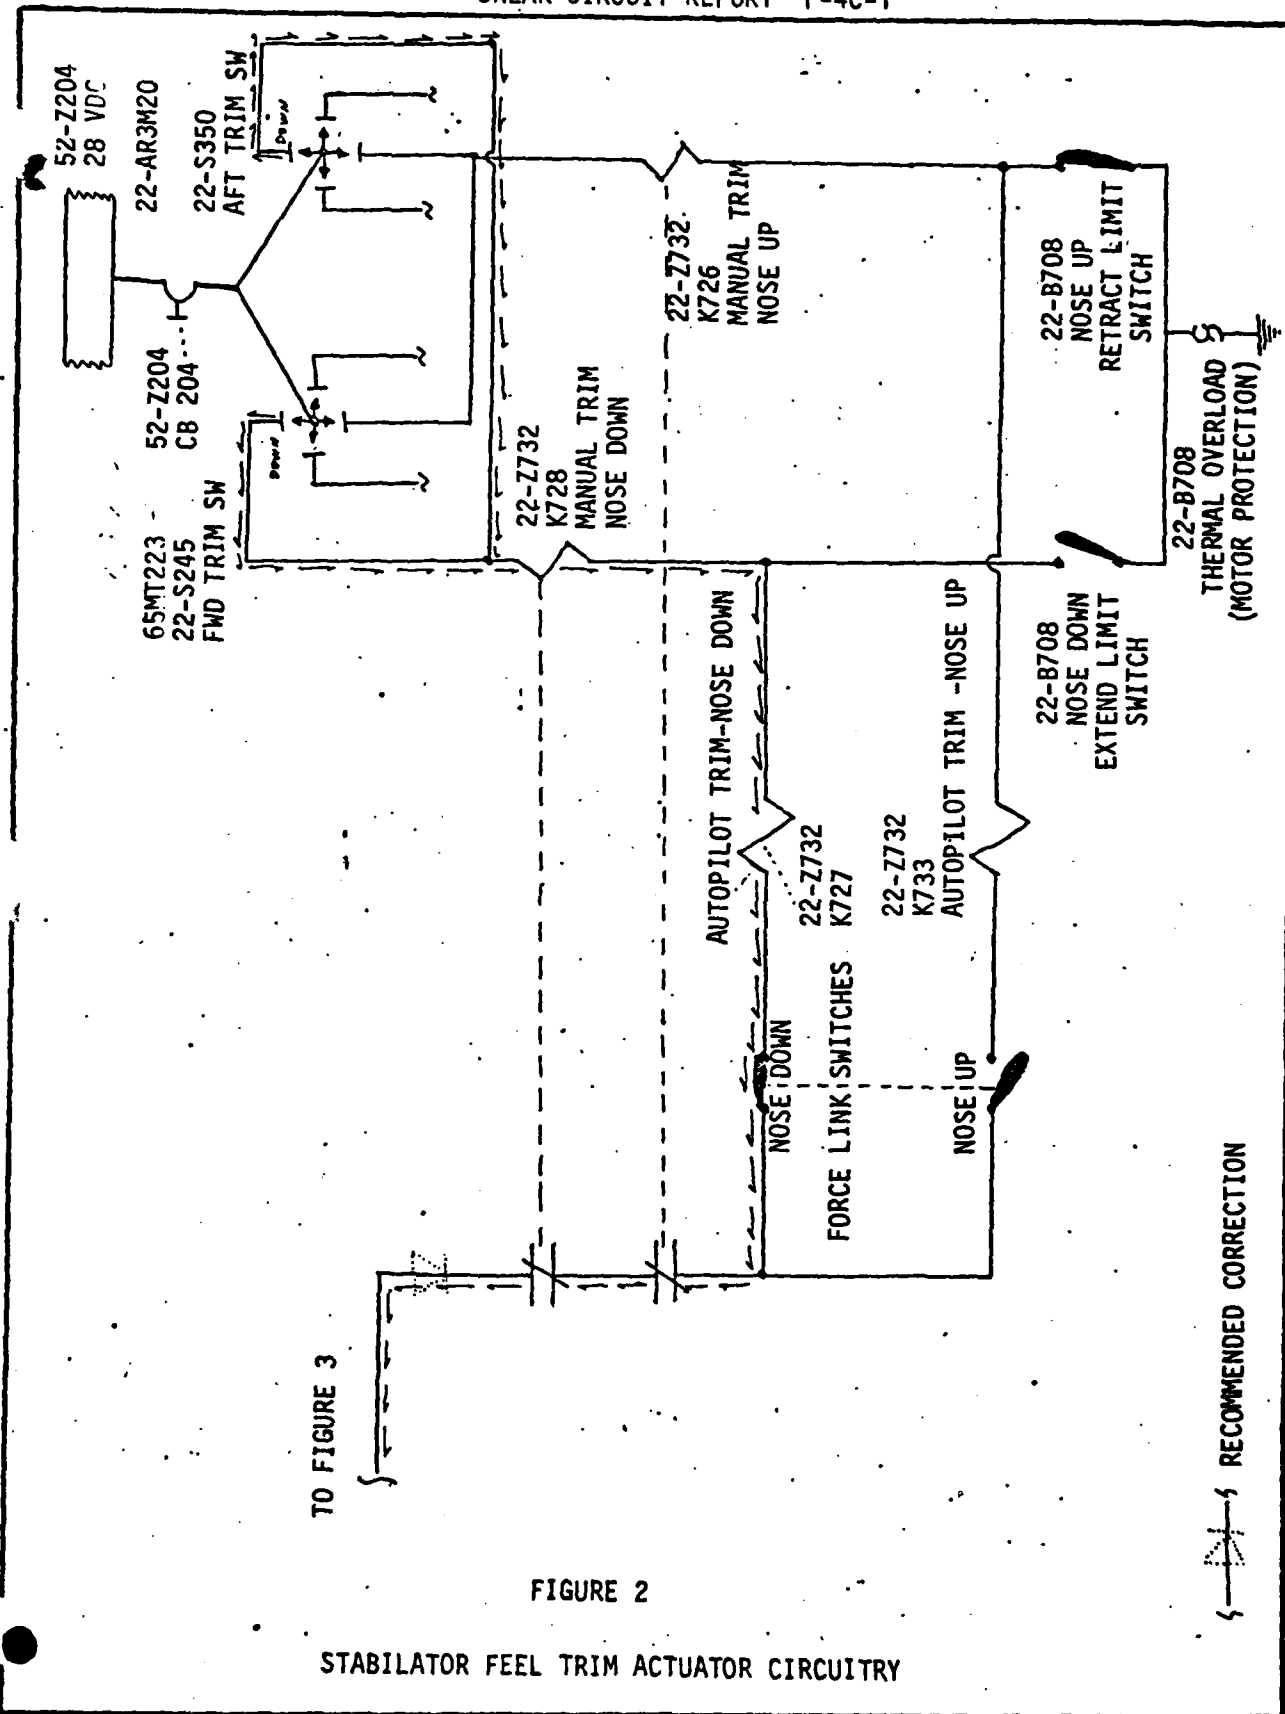
FIGURE 2

As shown in figure 2, a similar sneak path results when the Stabilator Feel Trim Actuator Motor reaches its extend limit and the Nose Down Extend Limit Switch in ref. des. 22-B708 opens. If a trim switch is then pushed to the Down position when either control stick is pushed forward, the Nose Down Force Link Switch (22-S719) is closed, current will flow through the Manual Trim-Nose Down Relay (K728) in ref. des. 22-Z732 and the Autopilot Trim-Nose Down Relay (K727) in ref. des. 22-Z732. Current could then flow to ground by the paths described below:

STABILATOR FEEL TRIM ACTUATOR CIRCUITRY

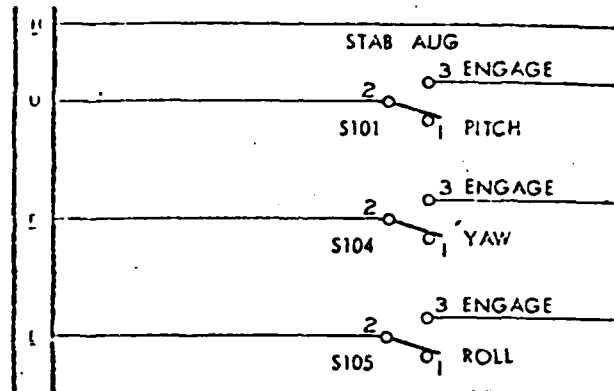
- 1) T.O. 5A1-2-42-2, Figure 5-12, Change 2
Normally Open, Latching. H common to all pin 3 contacts.
- 2) Schematic, Electrical-System AN/ASA-32M Control Circuits
Drawing #281E402, Sheet 4, Revision A, 2-16-71
Normally Open, Latching. H common to all pin 1 contacts.
- 3) Schematic, Electrical-Engaging Controller
Drawing #702187, Rev. C, 5-7-69
Normally Closed, Momentary. H common to all pin 3 contacts.
